PROPOSED PIAZZA, SACRED HEART CATHEDRAL, BENDIGO

GEOTECHNICAL & PRELIMINARY ENVIRONMENTAL INVESTIGATION

**GTS Report Number 15C 0697
Sept 2015**

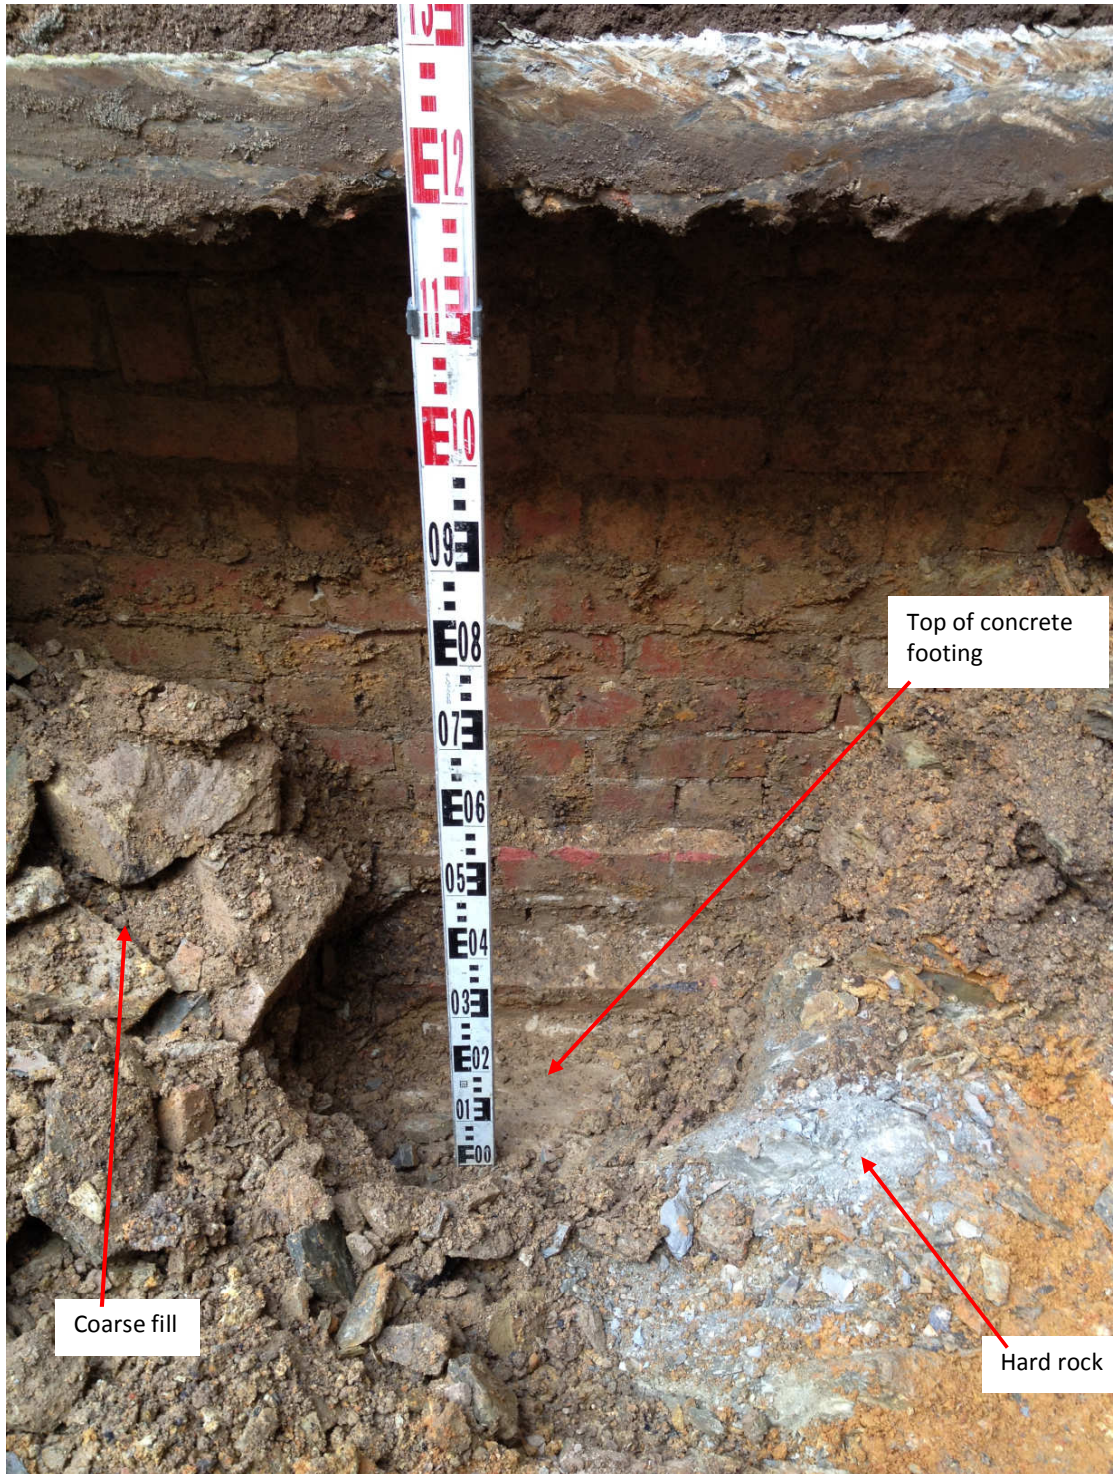
Fig 1: Footing Exposure

The footing exposure on the Cathedral indicated that the external footing was located in the moderately weathered Siltstone rock. It was observed that the top of the concrete strip footing was at a depth of 1.3 metres below the surface whilst the weathered Siltstone rock commenced at a depth of 1.05 metres. Due to the hardness of the rock, it was not possible to excavate to find the base of the footing, however, due to the hardness of the rock, this is not necessary. Photographs of the footing exposure are included in the Appendix. Based on the strength of the rock at this location, there is an allowable bearing pressure of 1MPa. However, with the variation in weathering of the Siltstone rock, throughout the site, the strength of the founding rock may also vary with recommendations discussed in Section 4.
